REPORT OF FATAL COAL MINE BUMP (OUTBURST) ACCIDENT

MOSS NO. 2 MINE
CLINCHFIELD COAL COMPANY
CLINCHFIELD (P.O. DANTE), RUSSELL COUNTY, VIRGINIA

December 13, 1967

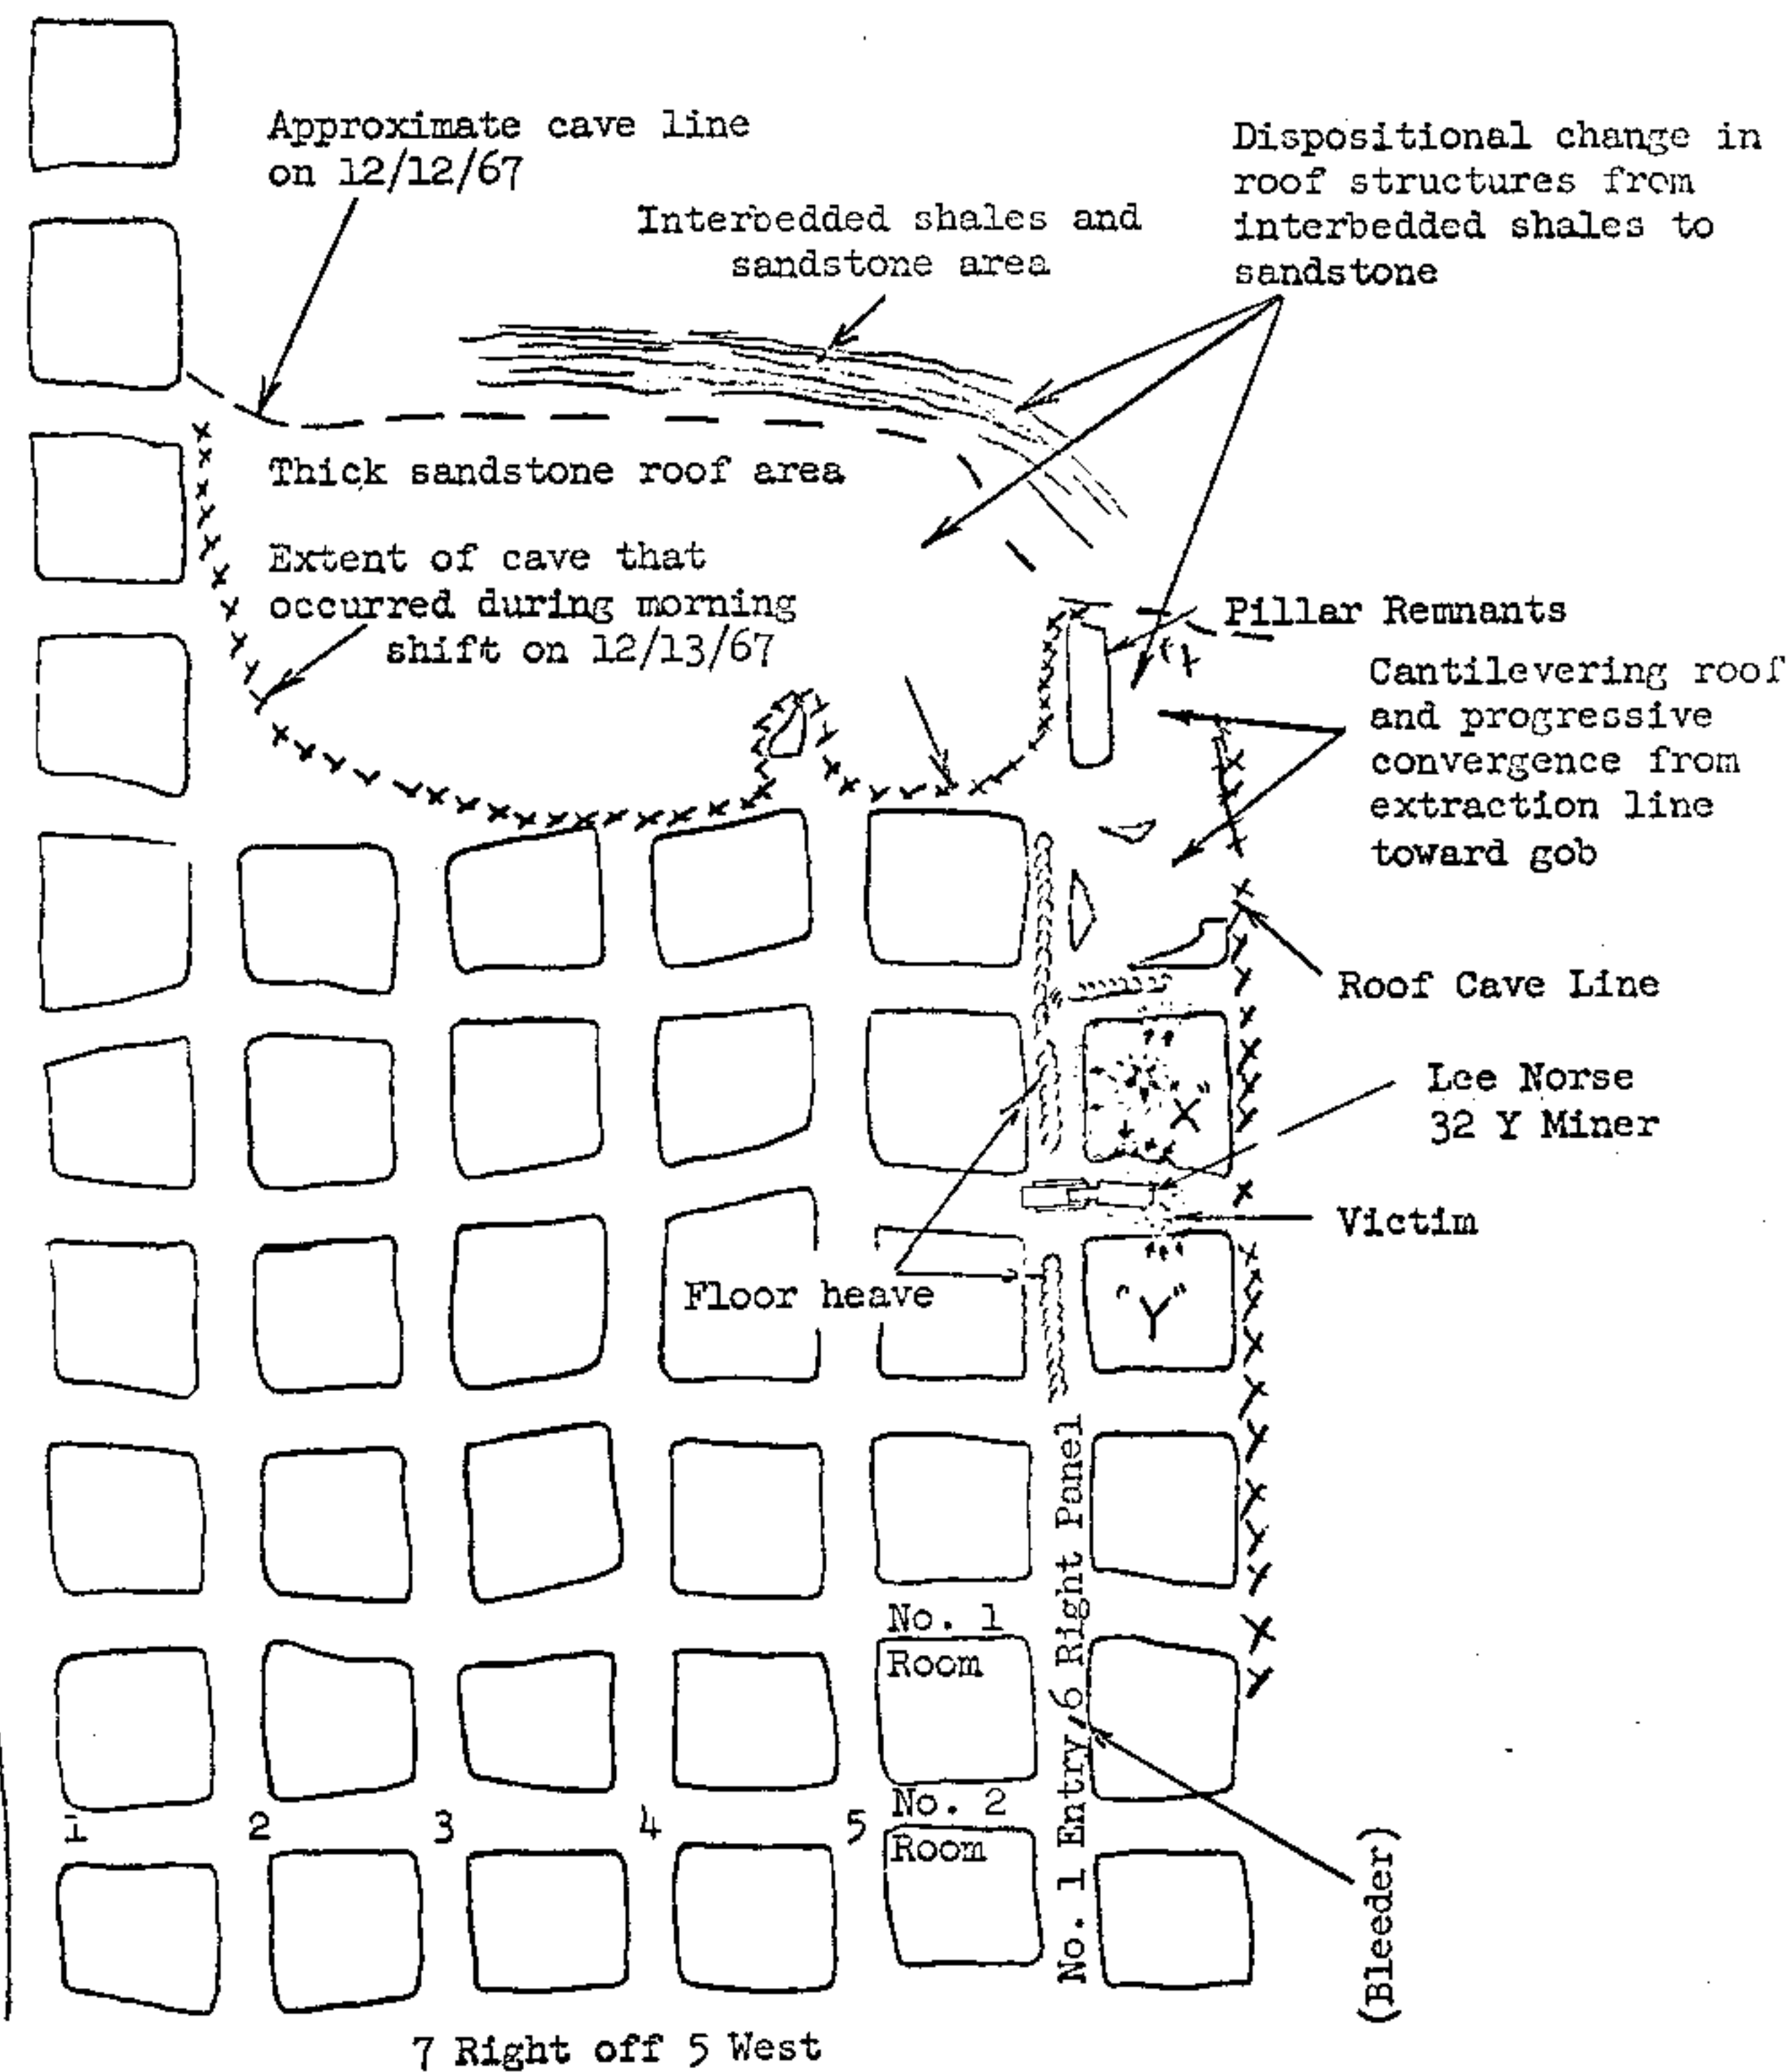
SKETCH NO. 1

The locations of men and equipment and the extent of mining in the area at the time of the outburst are indicated in Sketch No. 2. The active area of 7 right, the extent of extraction and the cave line prior to and at the time of the occurrence, are indicated in Sketch No. 1.

or a total of 10 pillars, had been extracted. This fall extended outward from the area where a dispositional change in roof structure (from a shales to thick sandstone) occurred 150 feet inby the current extraction line on the day of the outburst; however, from visual observations by the investigators, it was obvious that the fall was incomplete. The fall had terminated along the bleeder entry projection and cantilevered for 2 pillar lengths (150 feet) directly inby the pillar involved in the bump. This section of roof did not cave until after pillar "X" and two additional pillars were extracted on December 19. A factor that in all probability impeded caving of this section of roof resulted from unsuccessful attempts to mine the "C" wing of the second pillar 150 feet inby the "X" bleeder pillar (scene of accident) and of other pillar remnants observed at other locations within the specific area, as indicated in Sketch No. 1.

6. Pillar remnants formed "island abutments" in the gob that in all probability impeded the desired sharp caving close to the line of extraction.
